# A View from the Canals:

## Canals can leak, Sometimes drastically

Craig Simpson, P.E., Secretary-Manager  
East Columbia Basin Irrigation District

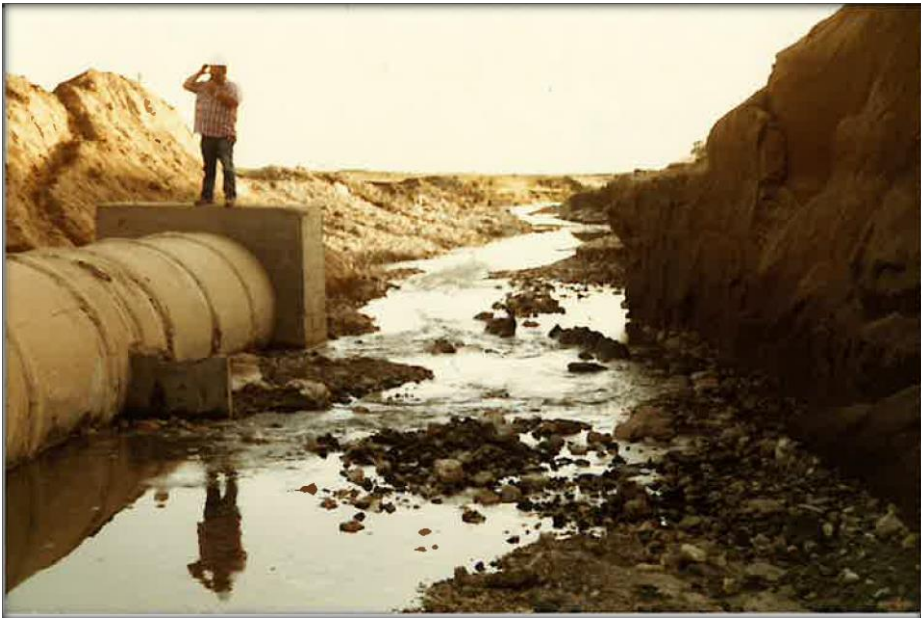
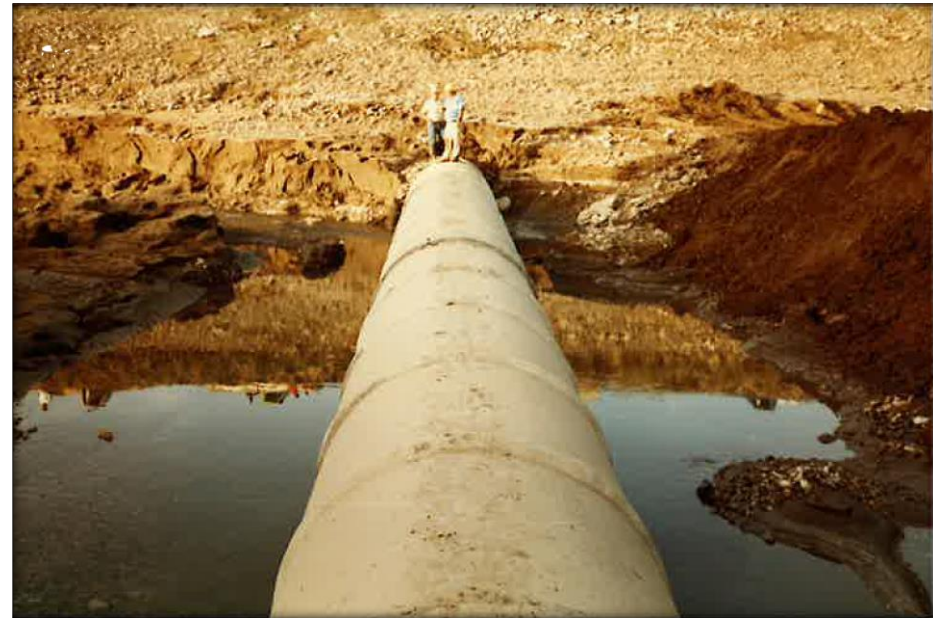
# EL 35.6 Mile Breach

- ▷ Canal failed June 16<sup>th</sup>, 1992
- ▷ Water piping along undershot

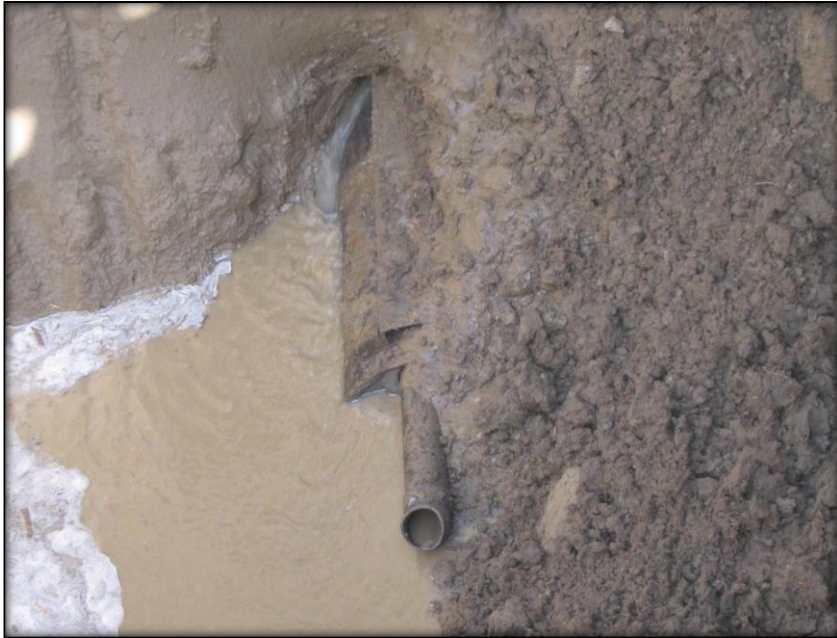
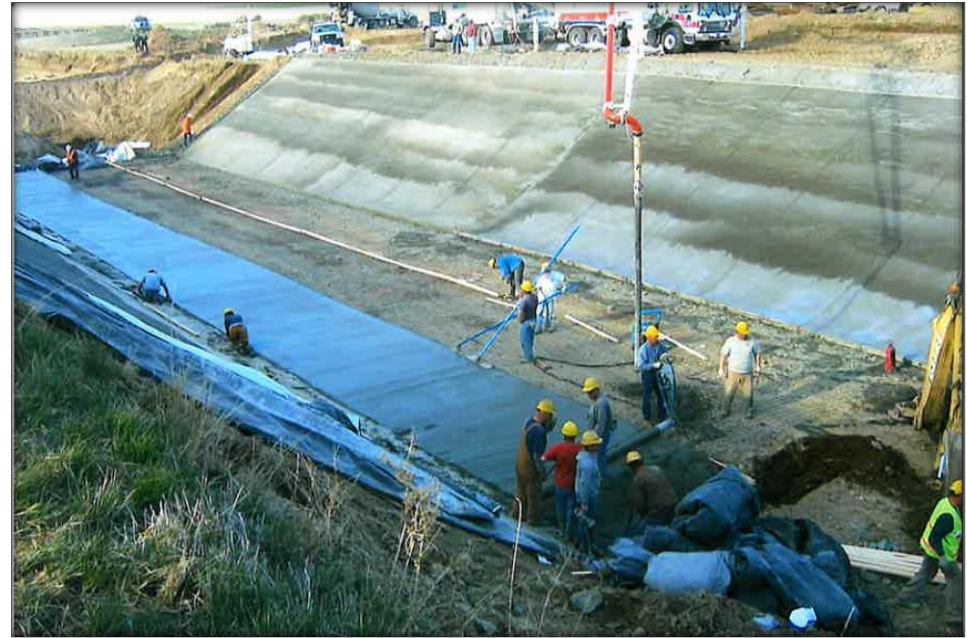
# EL 52 Mile Leak

- ▷ Leak detected early April 2008
- ▷ Caused by an ungrouted void around the casing of a utility bore under the canal

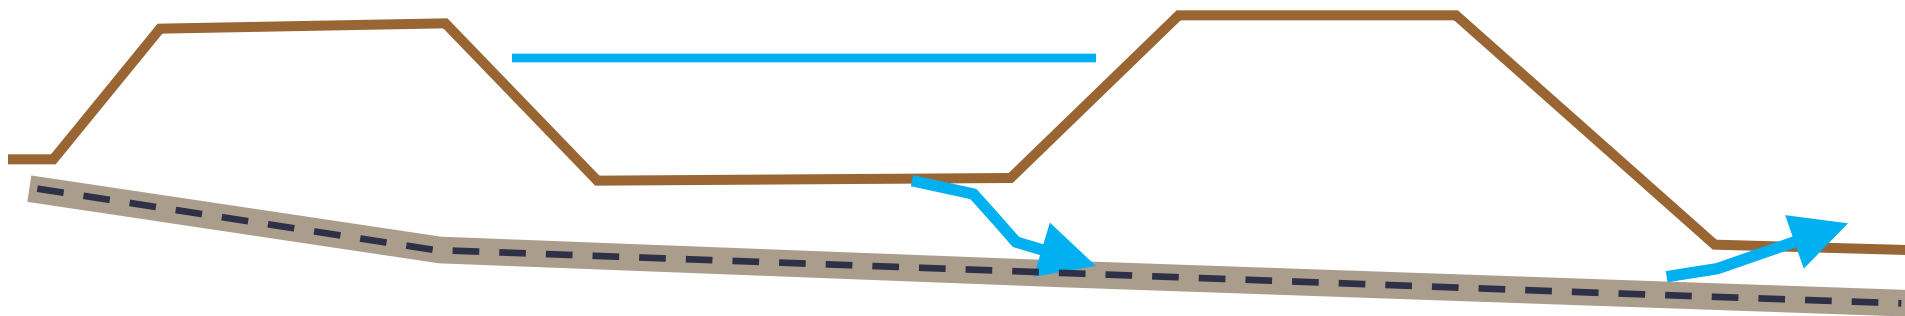
# EL 52 Mile Leak

Seepage Along Utility Crossing

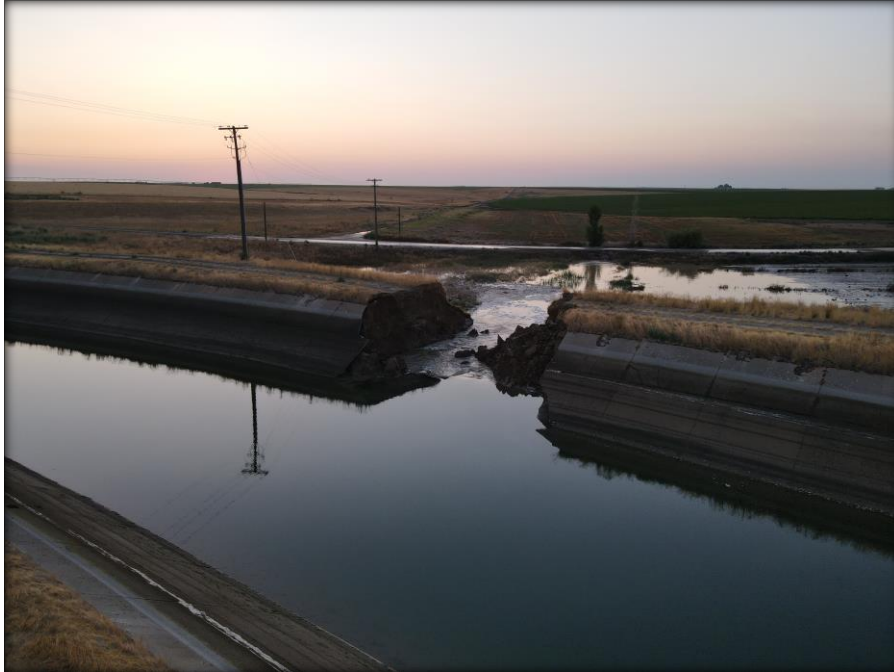
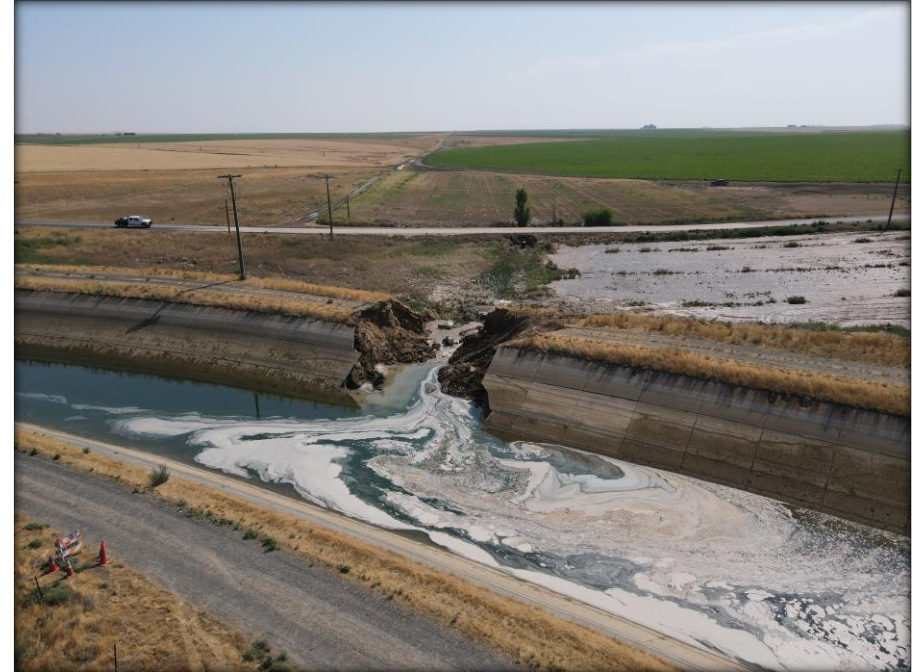
# EL 26 Mile Breach

- ▷ August 5<sup>th</sup> 2024
- ▷ Reported by landowner at 8:30 PM
- ▷ 3,100 CFS

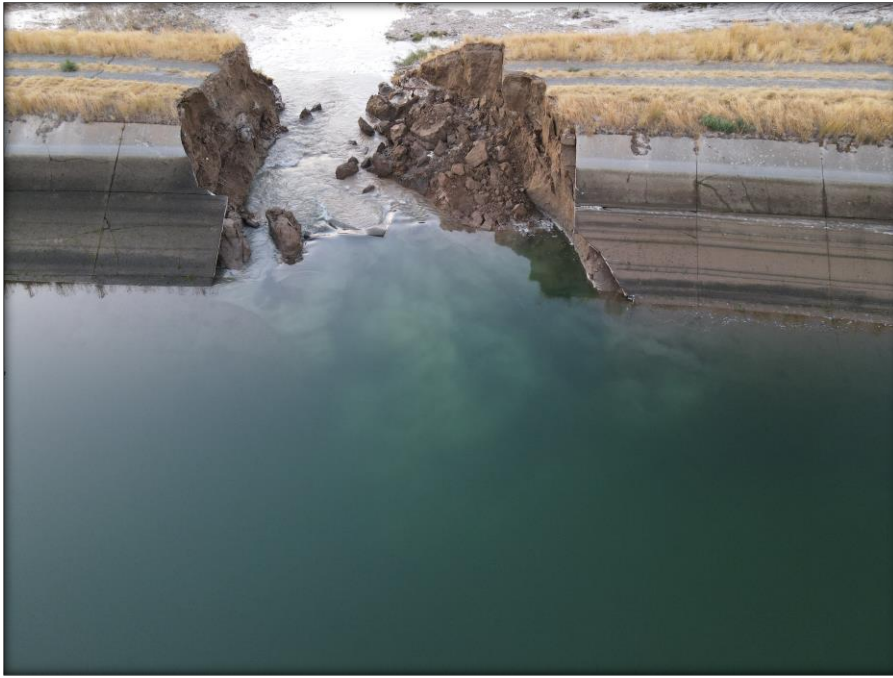
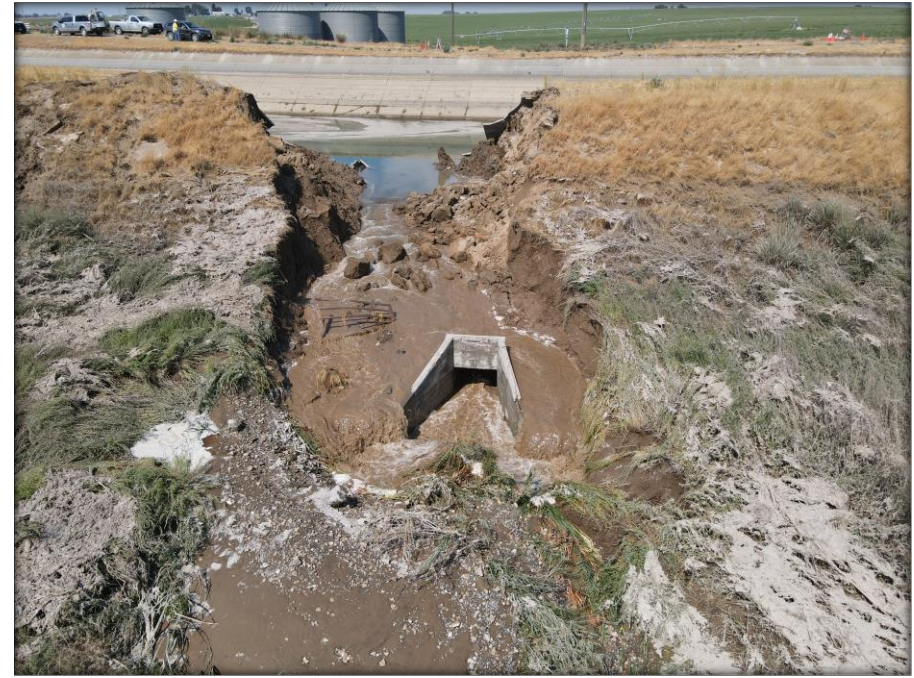
# Challenges in Dewatering

- ▷ Failure occurred near an undershot
- ▷ To the East (high side)

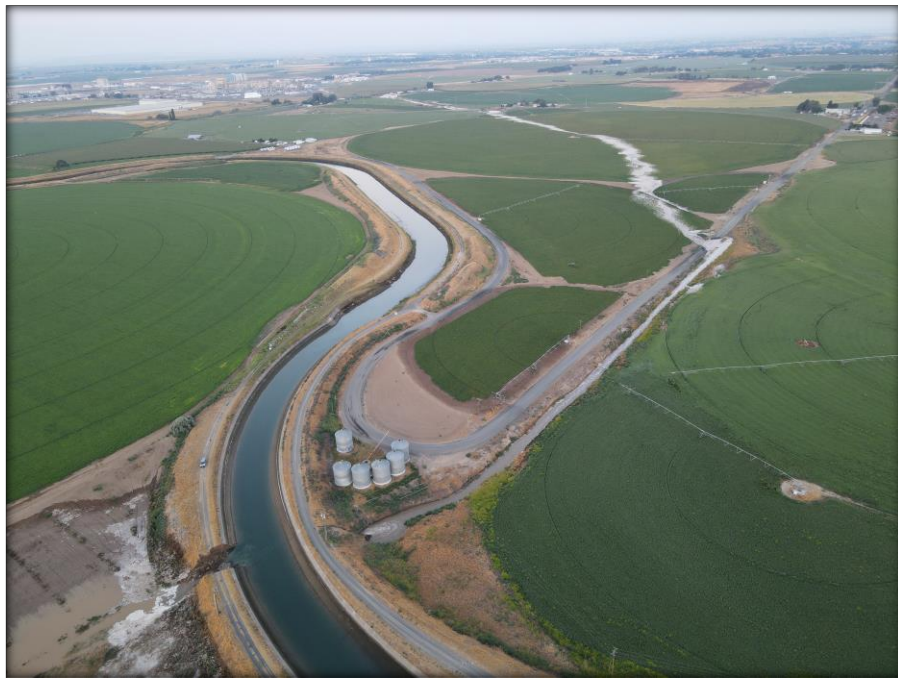
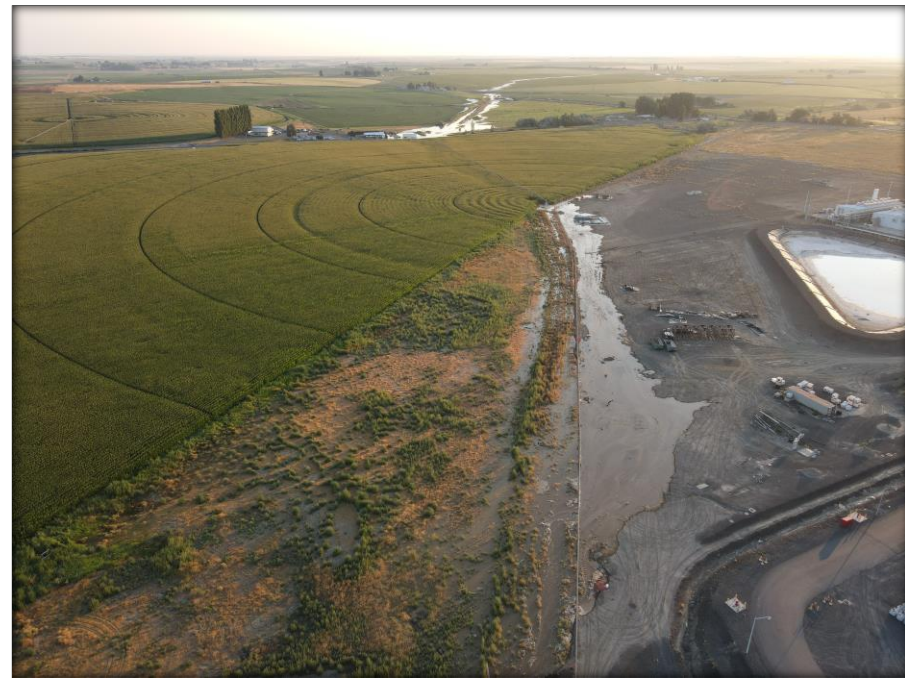
# Downstream Impact

- ▷ Impact limited compared to 1992 break
- ▷ Relatively minimal flooding
